84th Combat Sustainment Wing

Hill AFB HVOF Implementation

HCAT
27 Feb 08

13. SUPPLEMENTARY NOTES Surface Finishing and Repair Issues for Sustaining New Military Aircraft Workshop, February 26-28, 2008, Tempe, AZ. Sponsored by SERDP/ESTCP.

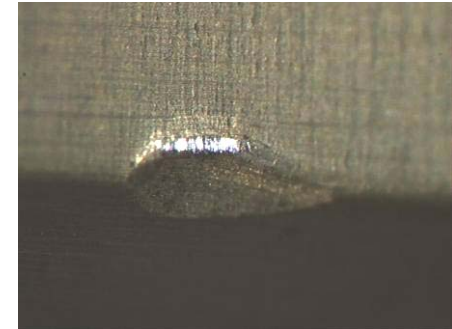
- The C-5 Lower Metering Tube (P/N 4G13518-101) has a history of leaks due to longitudinal scratches. The Lower Metering Tube develops scratches on its working surfaces both during new part assembly and during use in the field.

- The scratches are created by imbedded particles in the seals of the C-5 Floating Carrier Piston and/or anodize defects in the surface of the C-5 Floating Carrier Piston. The Lower Metering Tube is stainless steel or flash chrome and both surfaces have become scratched in service.

Three images (35X) of damage on mating surface, creating fine line scratches

- The cause of the initial scratches could not be determined. Damage was noted on the mating part, imbedded particles in the seal were not found. As a result both 240 and 400 grit aluminum oxide cloth was used to create a controlled, worst case test.
- As expected, the WC/Co performed better than the CrC/NiCr and NiCr coatings
- The application cost differences between the three coatings was relatively insignificant based on performance levels
- Currently both the Lower Metering Tube and its corresponding part on the C-5 Nose Landing Gear are being converted from Chrome to an HVOF applied WC/Co eliminating the in-service failures.

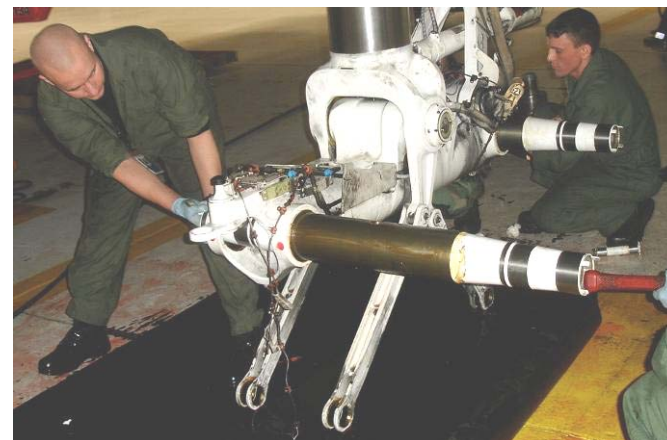
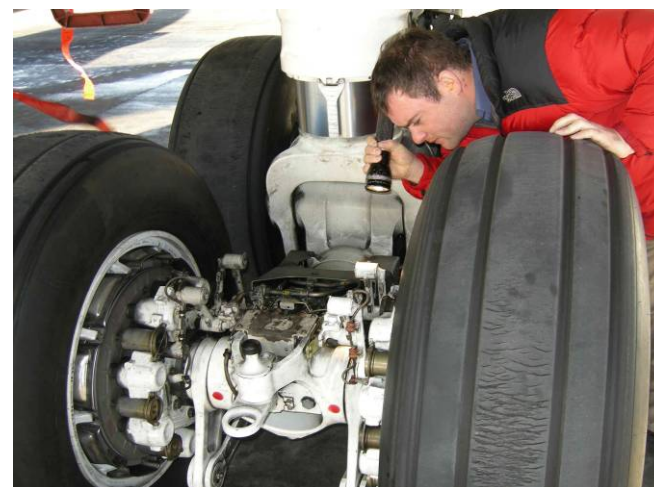
- The axles (P/N 1881B85) were installed in Dec 06. They have performed great while in service, due to the high brake removal costs, the axles have not been removed for further inspection to date

- In every past case, the axle beam bushings migrate with chrome axles and they re-migrate in service very shortly after being reseated.
- The HVOF axles, in service since Dec 06, have not encountered axle beam bushing migration.
